DESCRIPTIVE REPORT

Type of Survey TOPOGRAPHIC

Field No. PH-3 (LR) Office No. T-5593 50  
T-5600 incl.

Locality ANCHUTKA ISLAND

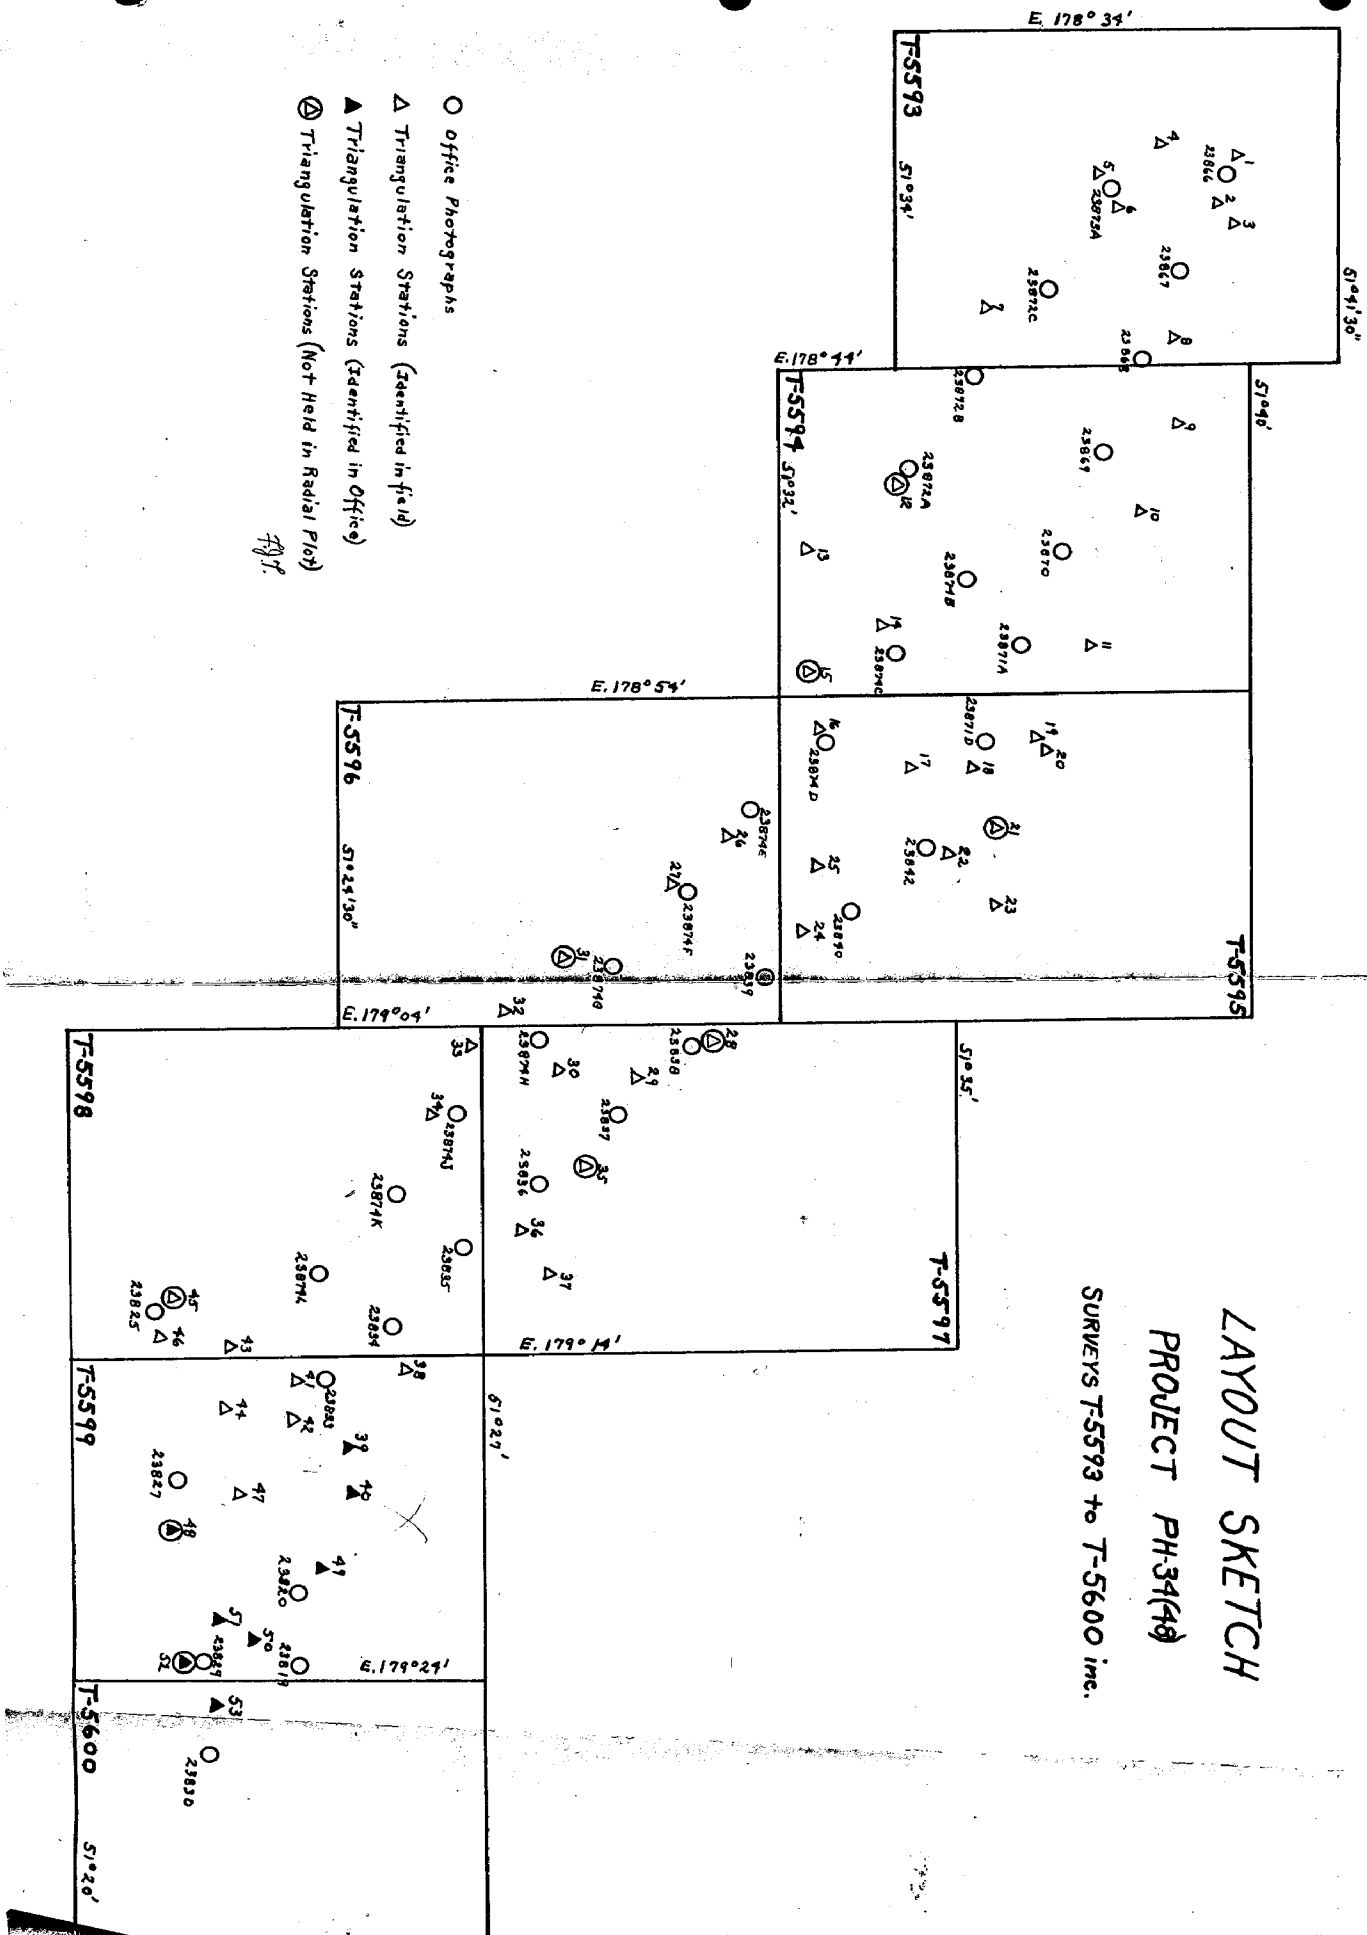
Fig. 1.

- Office Photographs
- △ Triangulation Stations (Identified in field)
- ▲ Triangulation Stations (Identified in Office)
- ⊙ Triangulation Stations (Not Held in Radial Plot)
